Case Study

Telecom Mast Foundation Fixings Testing

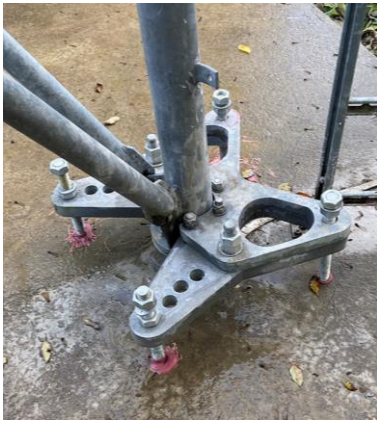
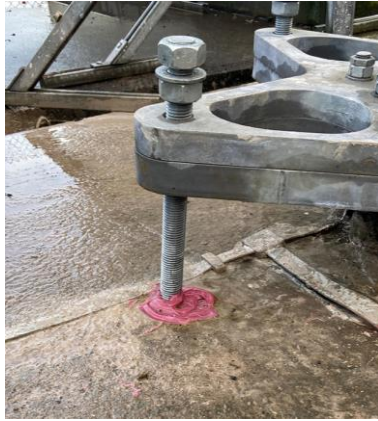
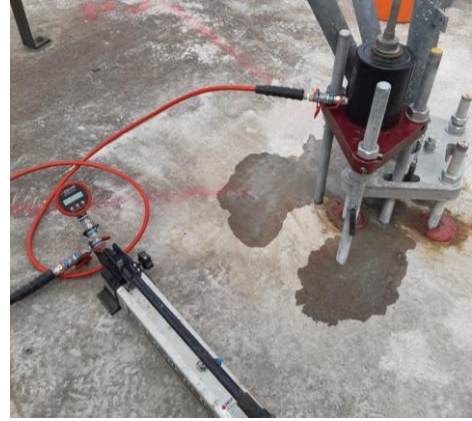
After visiting one of the sites and accessing the issues, Hydrajaws recommended using the Hydrajaws 330kN Hydraulic Hollow Cylinder Tester Kit.

The cylinder has a hollow piston to enable a rod to be passed through the entire cylinder length making it suitable for applications where a high pulling force is required on a rod diameter of up to 39mm.
